# TEST REPORT

## Load tests of the beam unit of BCC 250

**SB-Produksjon, Åndalsnes**

# ADDITIONAL REPORT

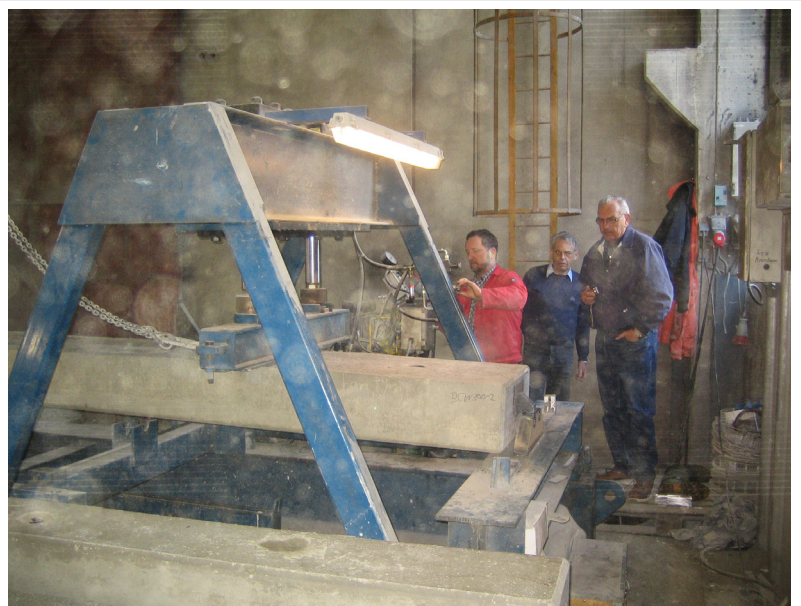
Figure 3. The test rig.

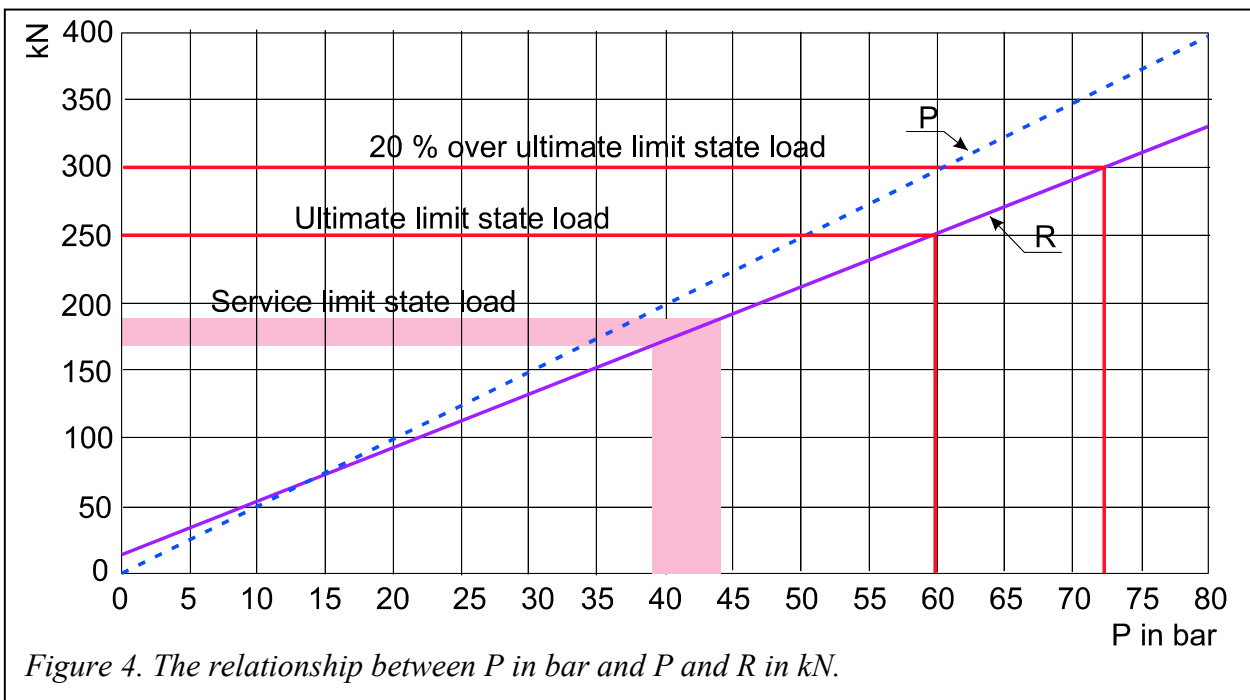
Figure 4. The relationship between P in bar and P and R in kN.

1 bar on the cylinders  
manometer corresponds to  
 $P = 4,97 \text{ kN}$

This means:  
 $R = 4,016 \times P + 11 \text{ kN}$   
(P i bar)

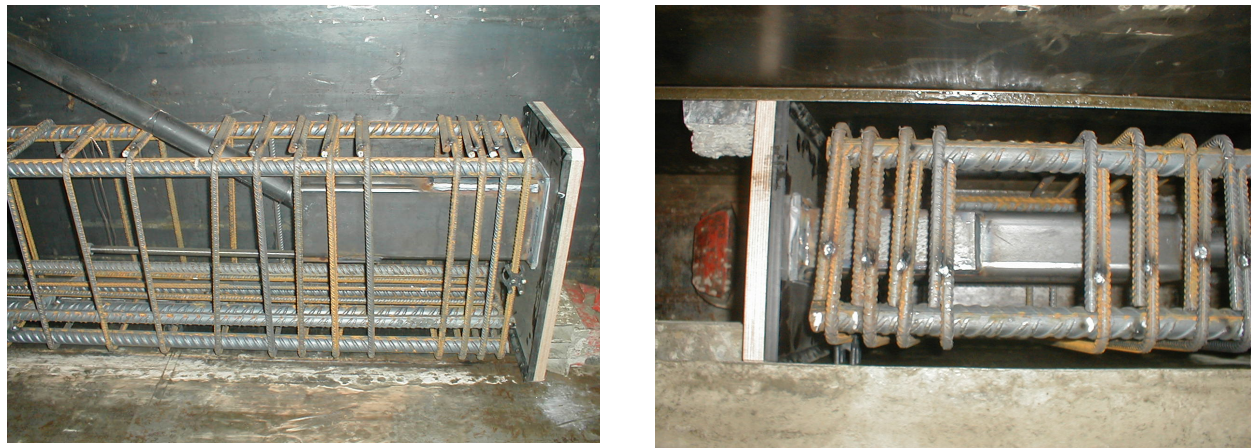
Figure 6. The reinforcement cage in the test beams.

Manometer reading P (bar)	Support reaction R		Observations	Reference
	kN	lb		
40	172	378	First visible crack. Crack width < 0,10 mm.	
50	212	466	Slight expansion of the crack. Crack width < 0,15 mm.	
72	300	660	Further crack development. Crack width $\approx$ 0,35 mm. Shear cracks in the beam.	Figure 14.
85	352	774	Violent bang, the concrete over the stirrups burst off – test terminated. All the stirrups had the "open" side up – as also can be seen on figure 6.	Figure 15 and 16.

The failure was caused by bending stresses perpendicular to the longitudinal axis of the beam at the beam end. Since all the stirrups had the lap splice of the legs at the top of the beam (the plan was that every second stirrup should have been upside-down), the horizontal part of the stirrup had poor anchorage for transverse stresses. The anchorage capacity to the concrete was exceeded, and it was the spot weld between the two legs of the stirrup (see figure 6) that provided the tensile capacity. At the instance when this spot weld failed due to these tensile

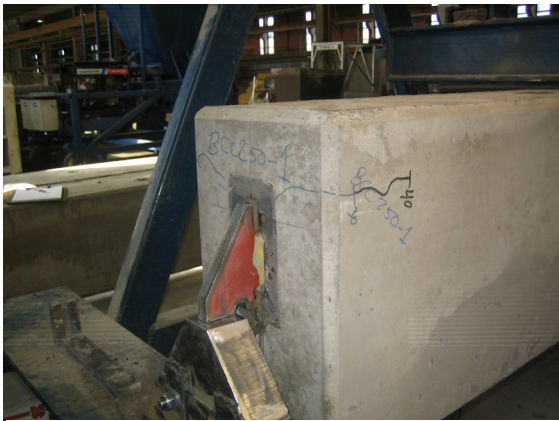
Figure 8. Test 1 at R ≈ 170 kN

Manometer reading P (bar)	Support reaction R		Observations	Reference
	kN	lb		
30	131	288	First visible crack.	
40	172	378	Slight expansion of the crack. Crack width < 0,15 mm.	Figure 8.
60	252	554	Further crack development. Crack width ≈ 0,25 mm.	Figure 9.
70	292	642	Further crack development. Crack width ≈ 0,35 mm. Shear and bending cracks in the beam.	Figure 10.
78	324	713	Crack width ≈ 0,60 mm. Test terminated. After load release the crack width went back to about. 0,2 mm.

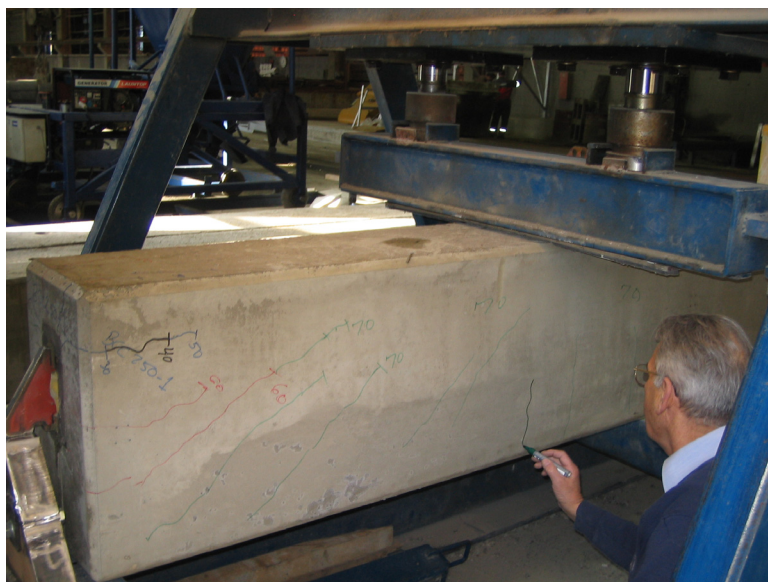
Figure 10. Test 1 at R ≈ 300 kN.

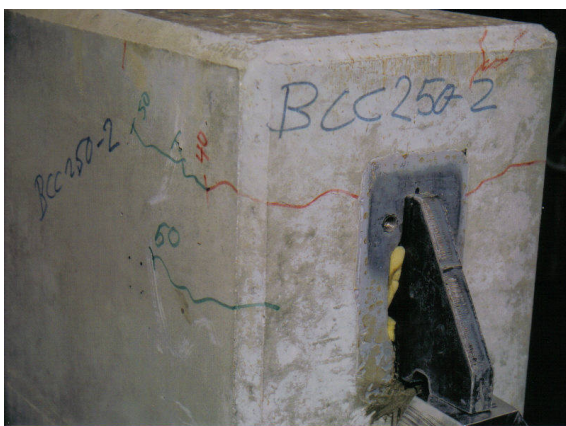
Figure 11. Test 2 at  $R \approx 210$  kN.

Manometer reading P (bar)	Support reaction R		Observations	Reference
	kN	lb		
40	172	378	First visible crack. Crack width < 0,10 mm.	
50	212	466	Slight expansion of the crack. Crack width < 0,15 mm.	Figure 11.
60	252	554	Further crack development. Crack width $\approx$ 0,25 mm. Shear cracks in the beam.	
80	332	730	Further crack development. Crack width $\approx$ 0,45 mm.	Figure 12.
90	372	818	Crack width $\approx$ 0,80 mm. Test terminated.	Figure 13.

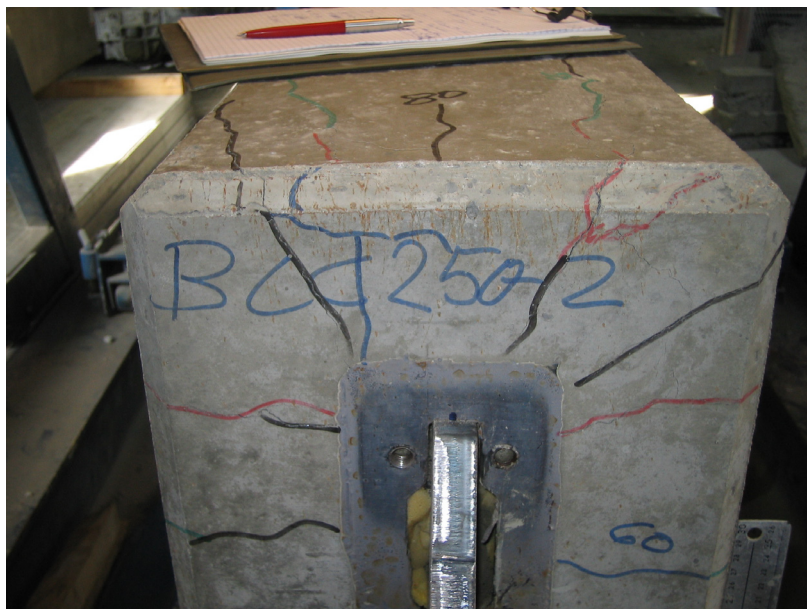
Figure 13. Test 2 at  $R \approx 370$  kN.

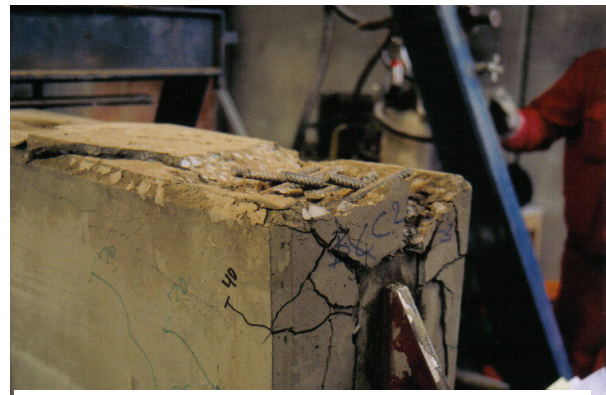
Figure 15. The end of test 3 after brittle failure at  $R \approx 350$  kN.

stresses, the stirrups straightened out, and a trapezoidal shaped concrete block was blown off over the BCC beam unit. This can be clearly seen in figure 15, which shows that the beam does not have any transverse expansion. This type of brittle failure can be prevented by placing the stirrups "upside-down". The reason that this particular test failed in such a way is probably caused by the somewhat uncertain quality of the grouting of the rectangular tube resulting in more concentrated loads against the concrete above the rectangular tube.

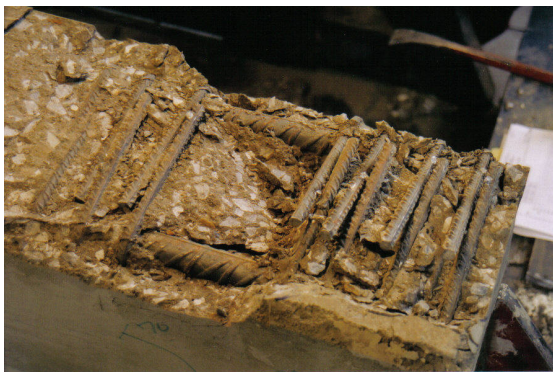
Figure 16. Top of stirrups after brittle failure at  $R \approx 350$  kN.

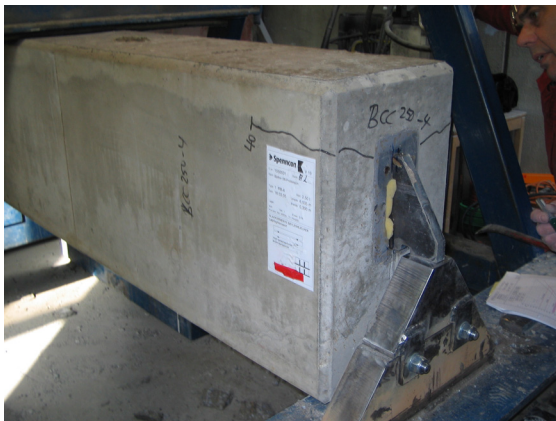
Figure 17. Test 4 at R ≈ 170 kN.

Manometer reading P (bar)	Support reaction R		Observations	Reference
	kN	lb		
40	172	378	First visible crack. Crack width < 0,10 mm.	Figure 17.
50	212	466	Slight expansion of the crack. Crack width ≈ 0,20 mm.	
60	252	554	Further crack development. Crack width ≈ 0,25 mm. Shear cracks in the beam.	
75	312	686	Crack width ≈ 0,6 mm.	Figure 18, 19 and 20.
85	352	774	Further crack development. Crack width ≈ 0,8 mm.	
89	368	810	Crack width ≈ 1 mm. Test terminated.

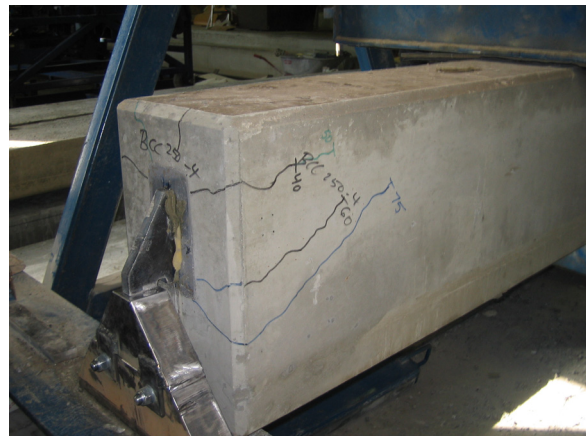
Figure 18. Test 4 at R ≈ 310 kN.

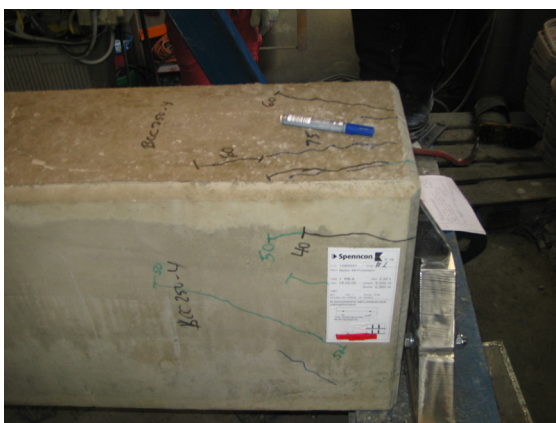
Figure 19. Test 4 at R ≈ 310 kN

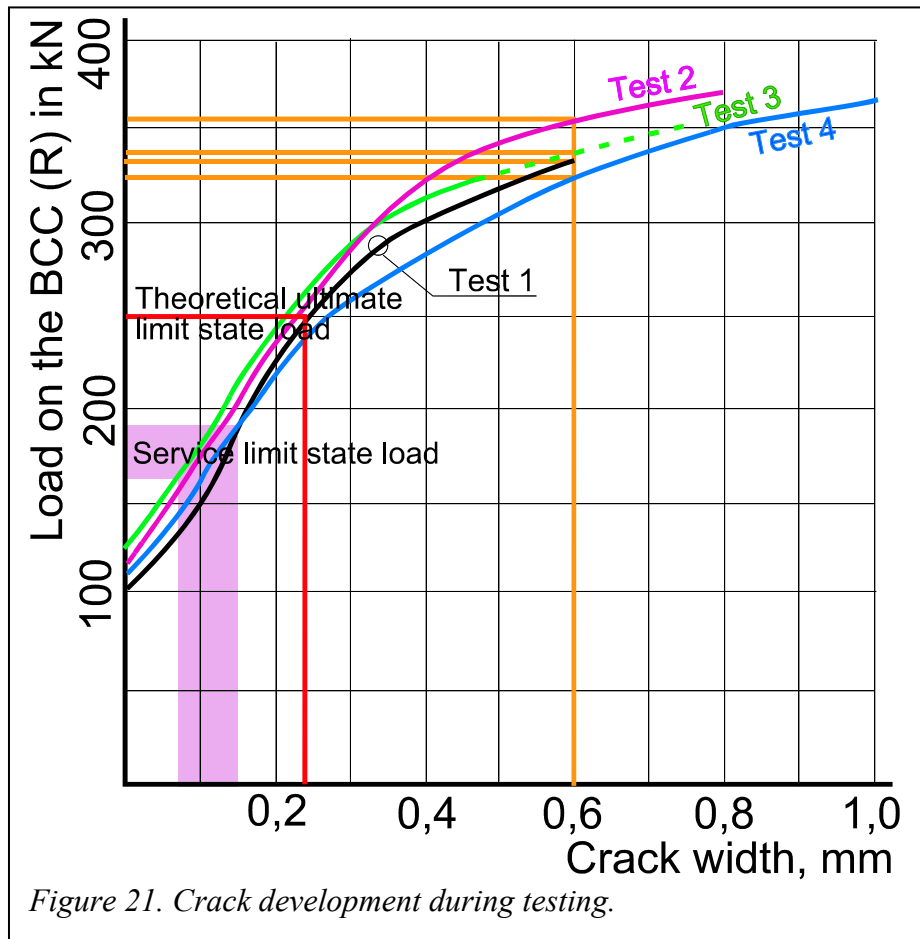
All tests had approximately linear crack development up to about 275 kN. After that the curves gradually changed direction, and the crack development became faster.

Figure 21. Crack development during testing.

Due to the lack of a clear failure load for three of the four tests, it was decided to define a crack width of 0,6 mm (3/128 inches) as failure.

Figure 21 also shows that within normal service limit state loads the maximum crack width will be less than 0,15 mm ( $0,0059 < 1/128$  inches), which is considered as a visually acceptable crack width both for professionals and laymen.

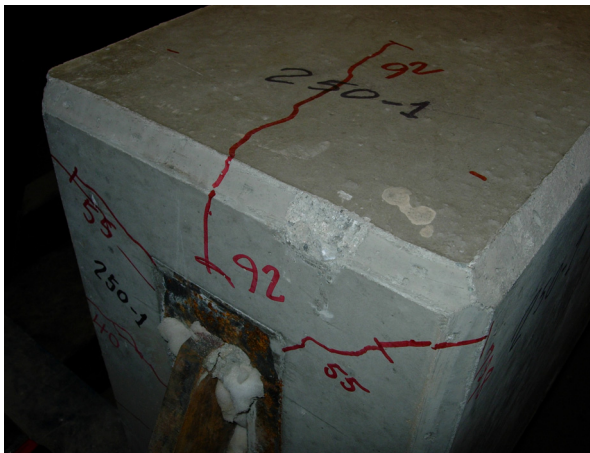
Figure 6. Beam end at R = 380 kN

Manometer reading P (bar)	Support reaction R (kN)	Observations	Reference
40	172	No visible cracks	
45	192	A few visible cracks, crack width < 0,10 mm	Picture on front page
55	232	A few visible cracks, crack width < 0,10 mm	
61,2	257	Slight crack development. Crack width < 0,15 mm	Ultimate limit state load
79,8	331	The beam has developed some bending and shear cracks. Crack width < 0,15 mm	
92	380	Cracks above the beam unit. Crack width < 0,15 mm	Figure 6
100,7	415	Crack width $\approx$ 0,25 mm	
106,2	438	Crack width $\approx$ 0,30 mm	Figure 7
109,3	450	Fracture of the knife.	Figure 8

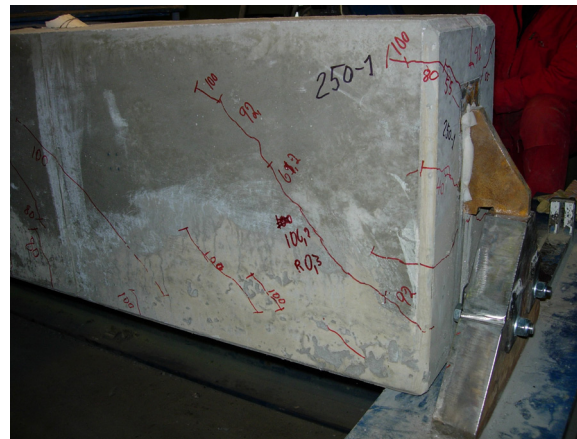
Figure 7. Beam end at R = 438 kN

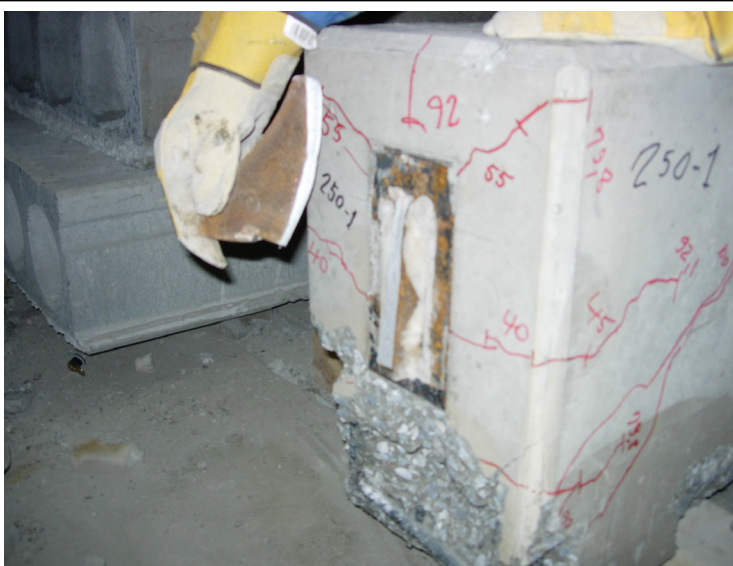
Figure 8. Fracture of the knife.
